Manhole Inspection Summary

Manhole # S21SS1019MH

Record Plat: **21SS1** Node: **019** Status: **Found**

Location Address: **HAMILL RD**

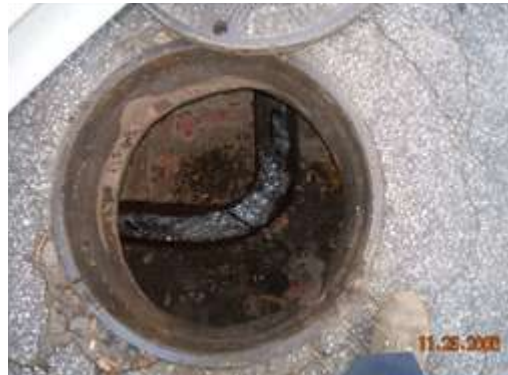
Top View

Evidence of surcharge - Bench debris.

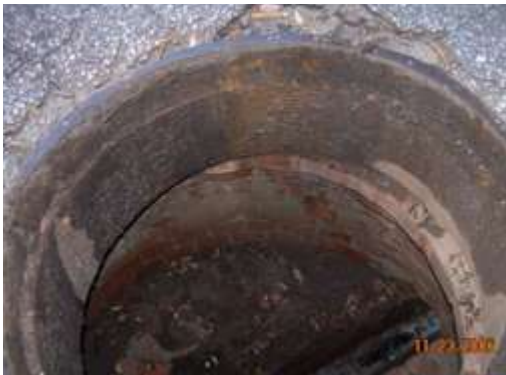
Defect

Frame Offset: **1** (in.) Condition: ☐ Sound ☐ Cracked ☒ **Leaks**

Infiltration: ☐ None ☒ **Joint** ☐ Cracks ☐ Mortar ☐ Roots ☒ **Wall**

Infiltration: ☐ None ☐ Joint ☐ Cracks ☐ Mortar ☐ Roots ☒ **Wall**

Frame leaks. Frame offset. Adjustment and Corbel infiltration.

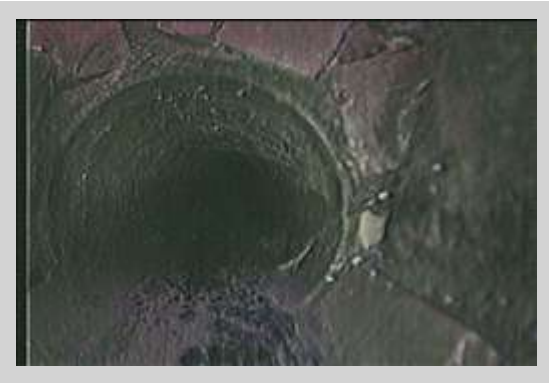
6 in. Circular Gravity Sewer Pipe Out @ 12 O'Clock

Infiltration: **Evidence** Pipe Seal Cond: **Unknown**

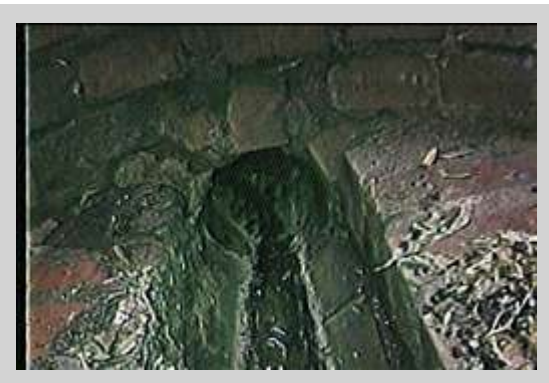
6 in. Circular Gravity Sewer Pipe In @ 9 O'Clock

Barrel deterioration and infiltration. Channel deterioration.

Deposits: ☐ None ☐ Mud ☐ Sludge ☒ Debris ☒ Grease

Infiltration: **Evidence** Pipe Seal Cond: **Broken**
